## A Survey of Thatched Buildings in Scotland

Thatch Survey of Scotland  
2014-15

A photographic survey of thatched buildings in Scotland, surveyed between May 2014 and August 2015 by Zoe Herbert (SPAB Scotland Officer), on behalf of the Society for the Protection of Ancient Buildings.

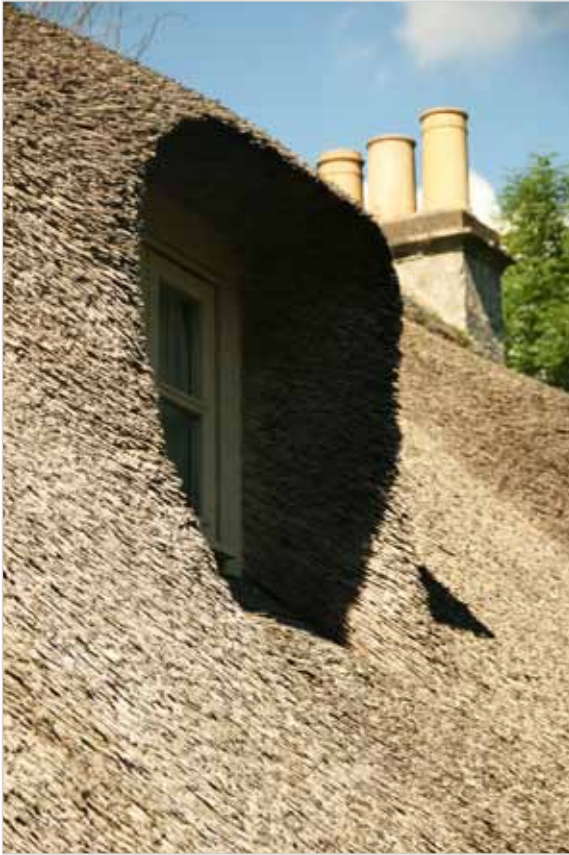
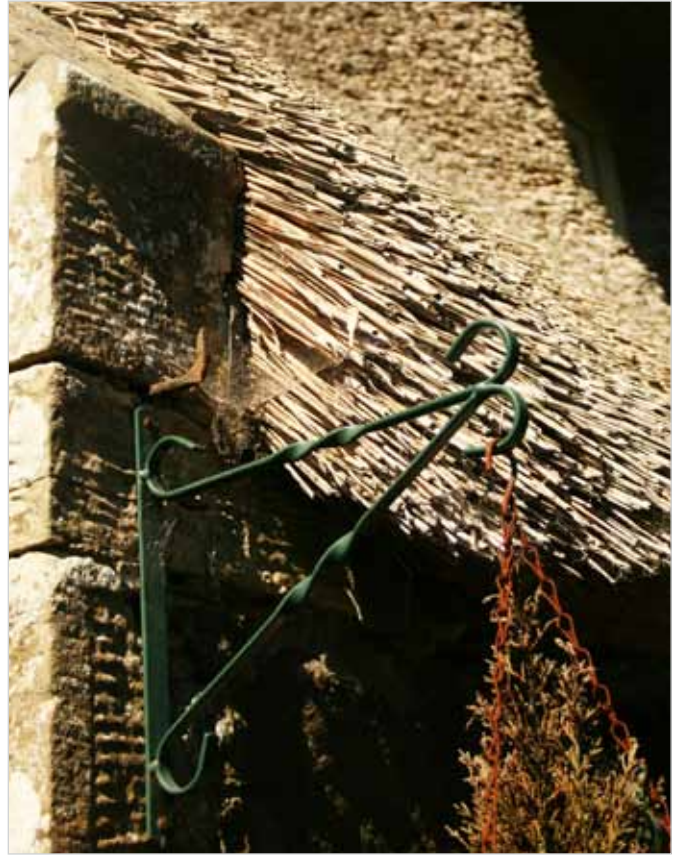
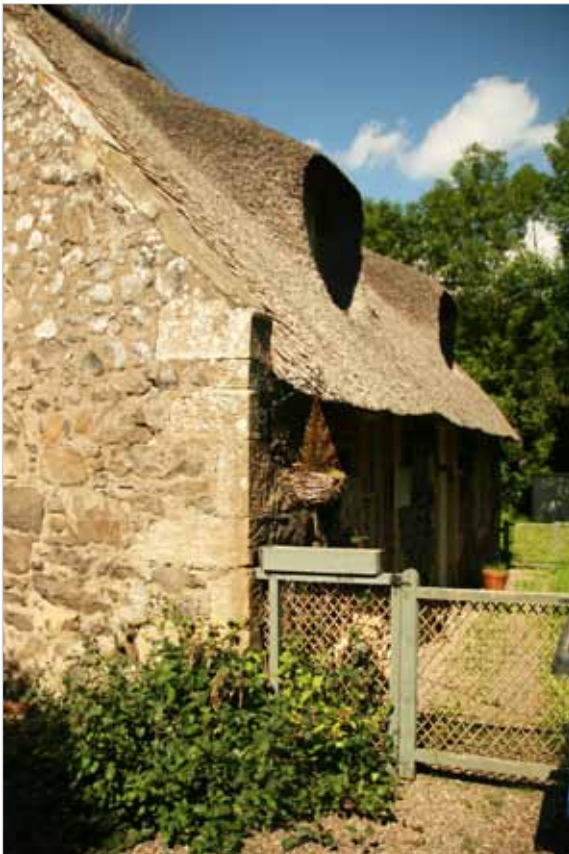
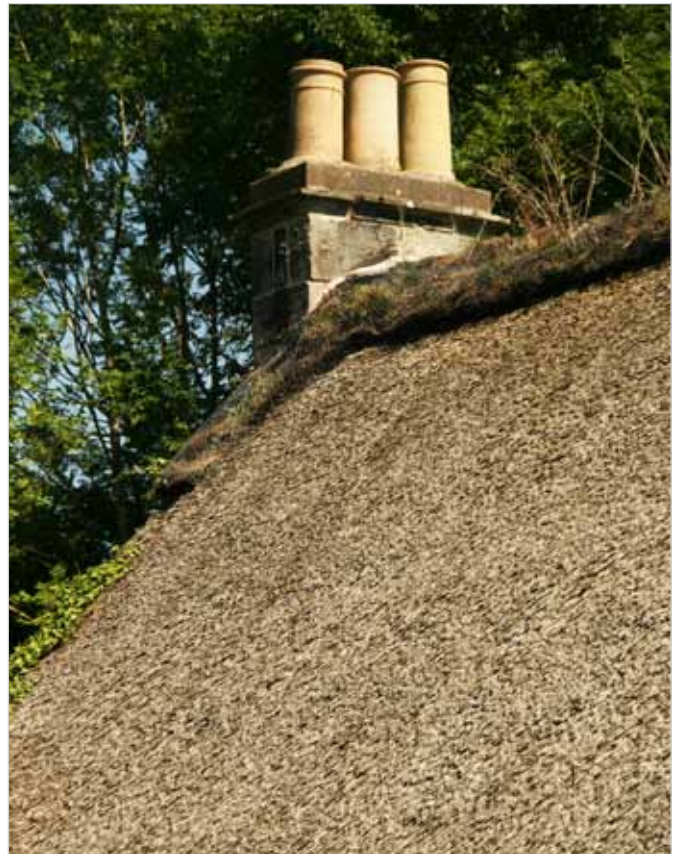
Southview Cottage – Fife

Condition of Thatch: ..... Good

**Additional Notes:** Late 18th-century cottage, single-storey with an attic and listed as having a 'felt tiled roof and being 'recently renovated'. The listed building description notes read '*Former Parish School, Unsympathetic roofing material*', which could perhaps explain a later decision to thatch the roof in reed. On the south (principal) elevation, there are two attic dormer windows within the thatched roof. The netted turf ridge is slightly overgrown with vegetation, whilst the rest of the thatched roof, which has been left uncovered, is in a good condition. On the north (back) elevation, ivy has grown up the gable, under the eaves, and onto the thatch. According to locals,

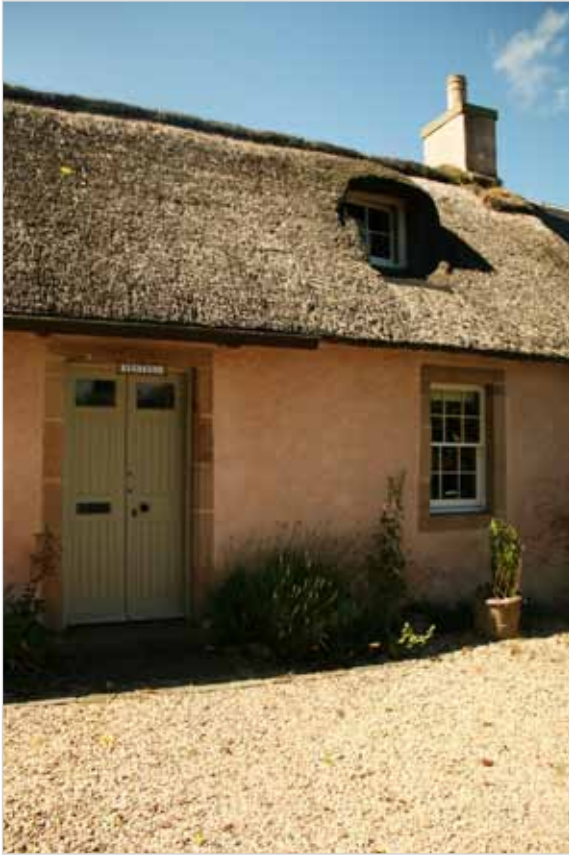
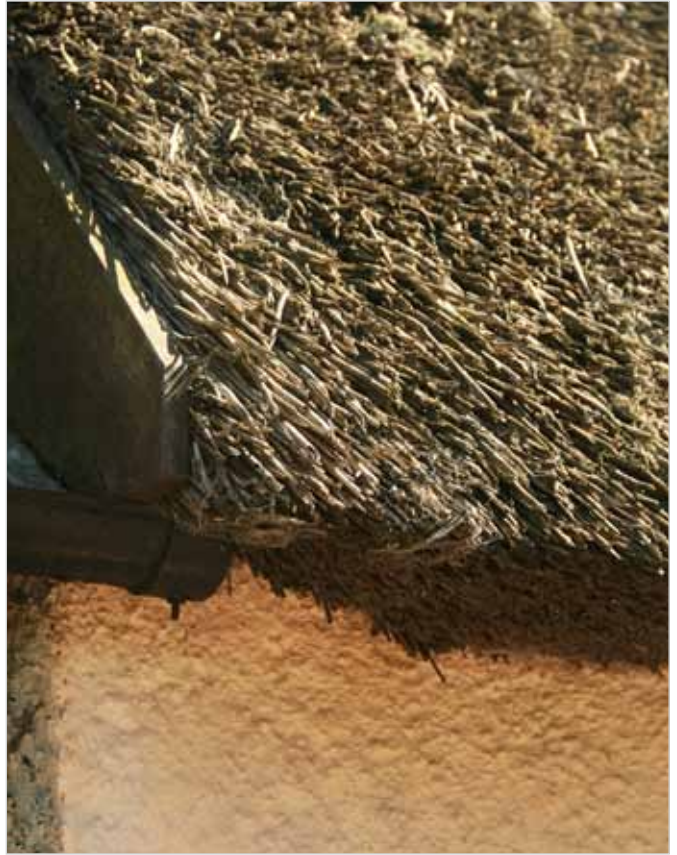
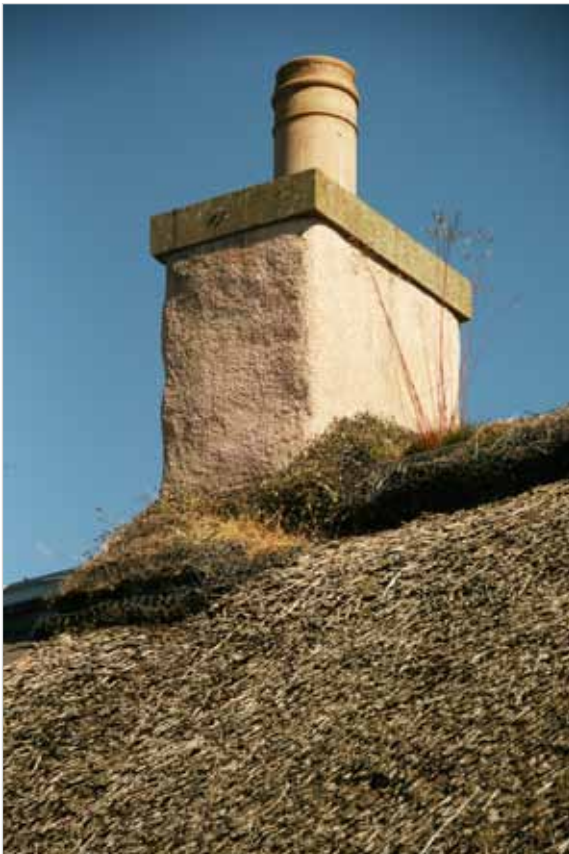
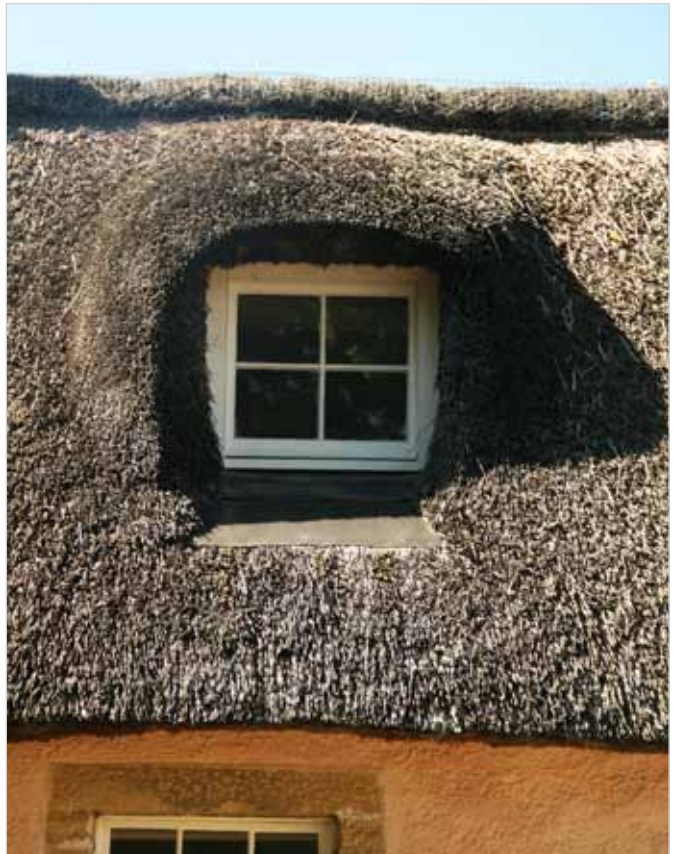
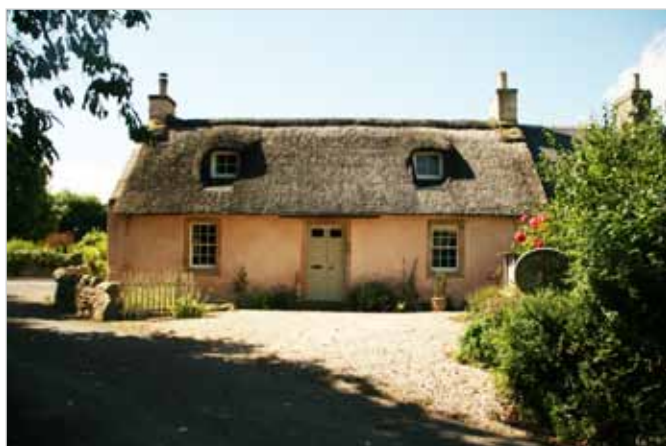
West End Cottage – Fife

Condition of Thatch: ..... Good

been used to contain the thatch. A snow board

has been installed above the front door.

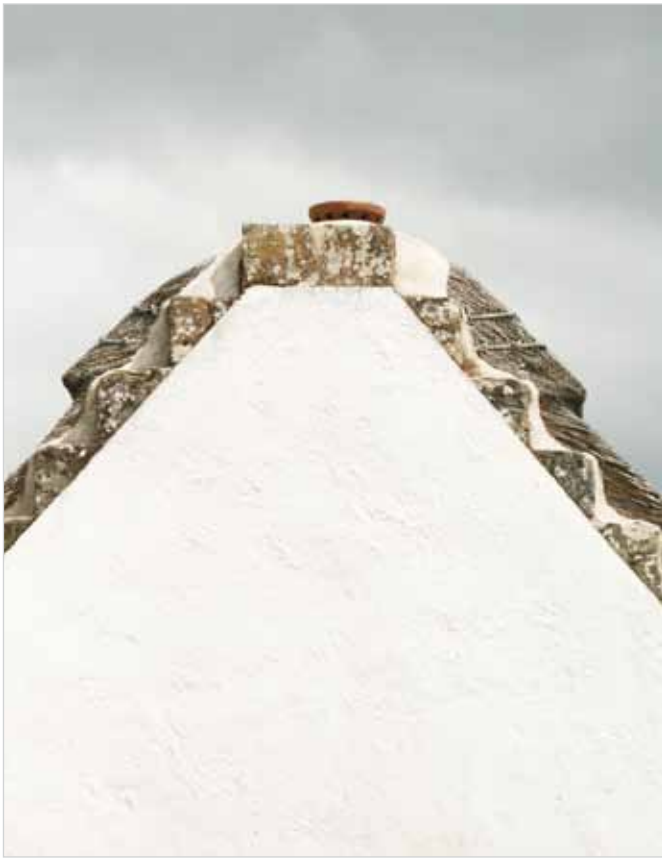
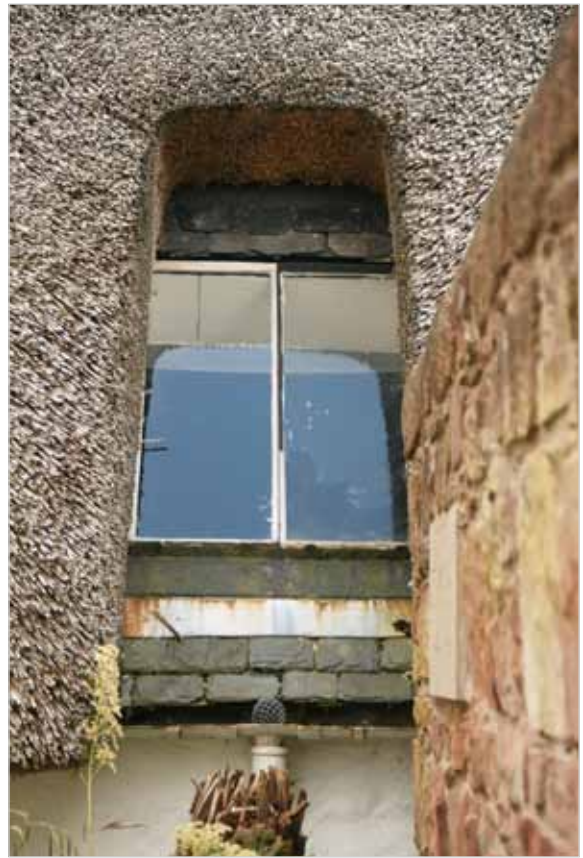
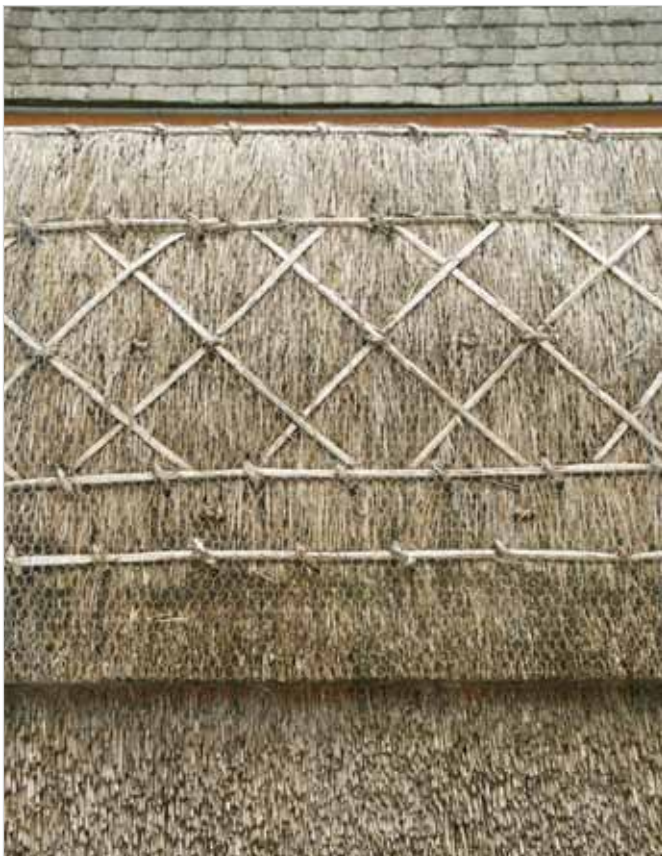
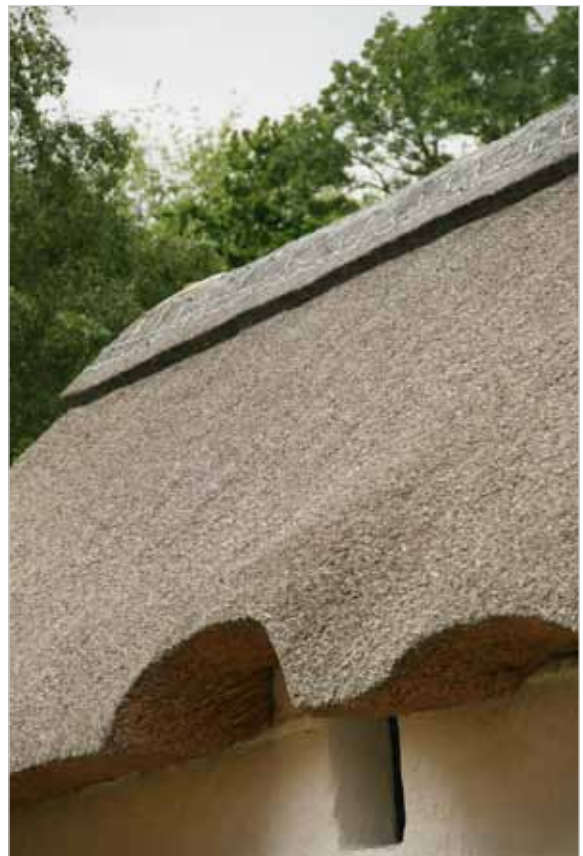
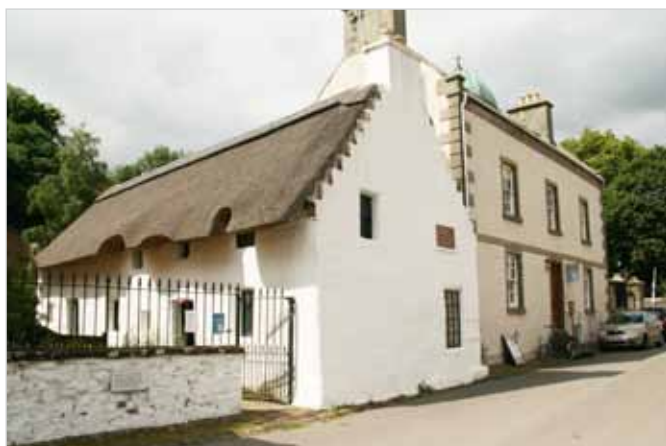
Hugh Miller's Cottage – Highlands

Address: ..... Hugh Miller's Cottage  
..... Church Street  
..... Cromarty  
.....  
Local Council: ..... HIGHLANDS  
.....  
Grid Reference: ..... NH 79002 67380  
Date of Visit: ..... 12/07/2015  
Thatch Type: ..... Reed  
Ridge Type: ..... Thatched (Straw)  
Condition of Thatch: ..... Good  
Additional Notes: ..... Early 18th-century two-storey cottage, made famous by being the birthplace of geologist Hugh Miller. The cottage is owned by the National Trust for Scotland and is part of the Hugh Miller's Birthplace Museum. The building was last re-thatched in 2010, in reed with a straw ridge, by thatcher Graham Carter. According to NTS literature on display in the building, the roof would have been thatched in turf topped with straw, or in heather. The longevity of the reed is why they chose this material for its last thatching. The straw ridge has been scobed with hazel spars, and extended decoratively below the chimney stack to the north. On

the south-east (front) elevation the thatch has been sculpted at the eaves above the three first-floor window openings, whilst on the north-west (rear) elevation there are two recessed window openings within the thatch, below which the roof has been slated to the eaves. The roof has been netted along the ridge only, whilst the rest of the thatch has been left uncovered.

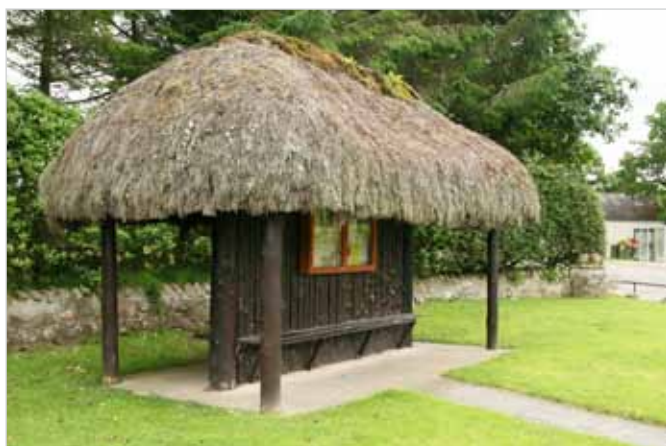
Edderton Community Shelter – Highlands

Condition of Thatch: ..... Good

..... school children in 1993 (<http://www.undiscoveredscotland.co.uk/edderton/edderton/>). There is a small amount

..... of mossy vegetation growth across the surface of the thatch.

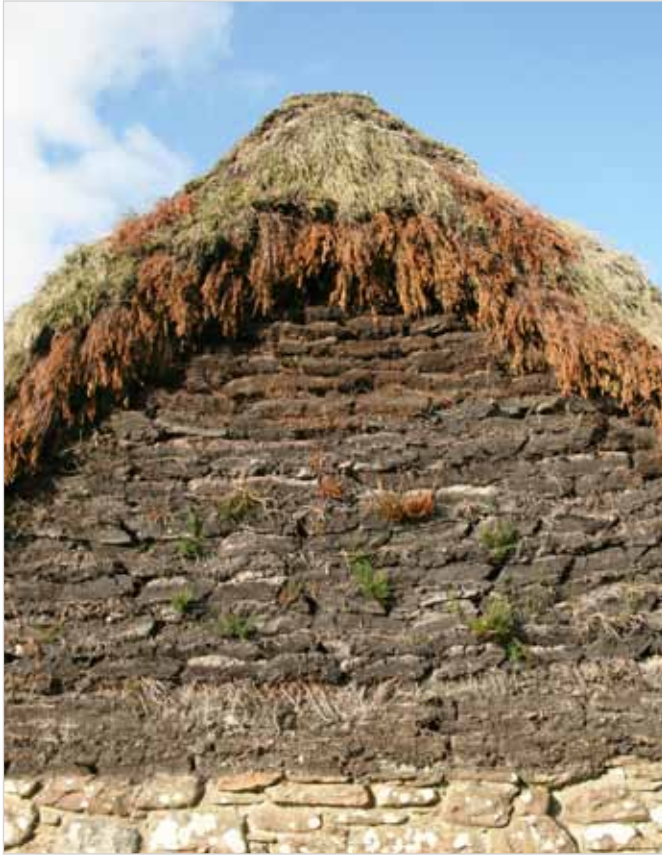
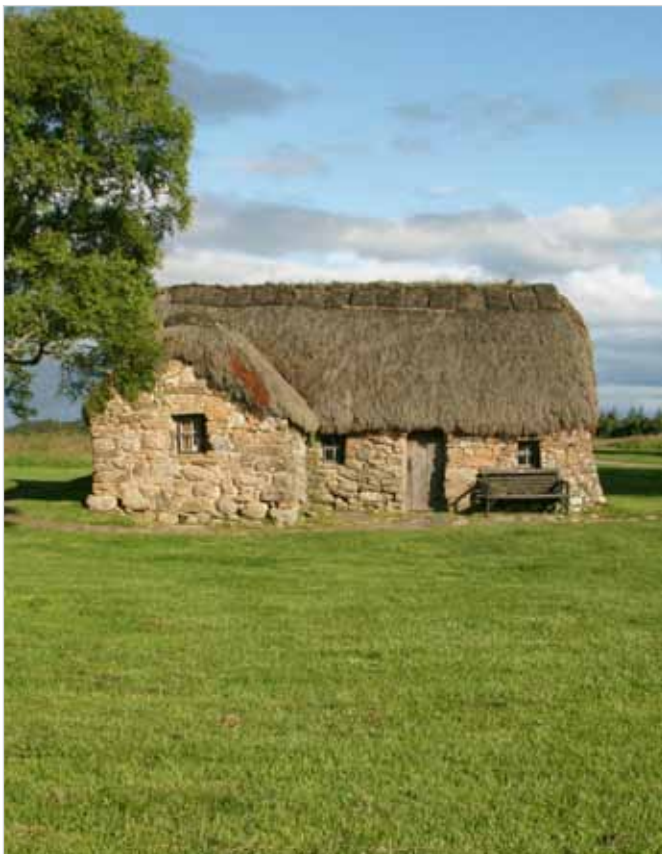
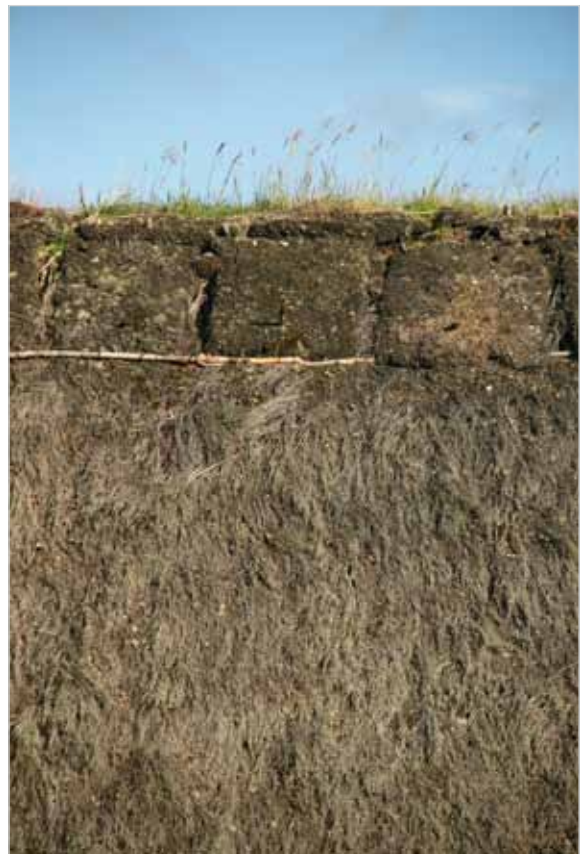
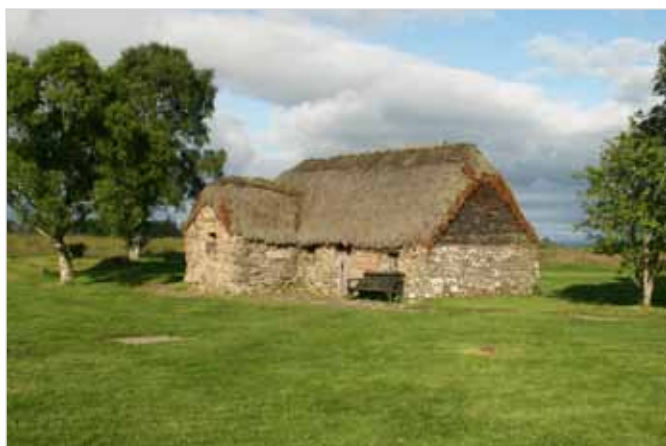
Old Leanach Farmhouse – Highlands

Condition of Thatch: ..... Good

tied down using these hooks at some point in the

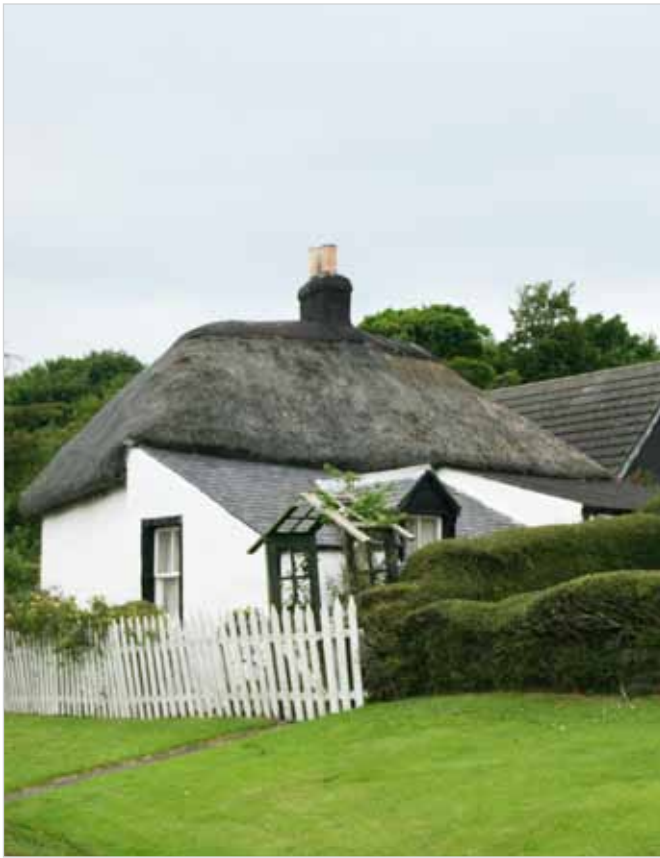
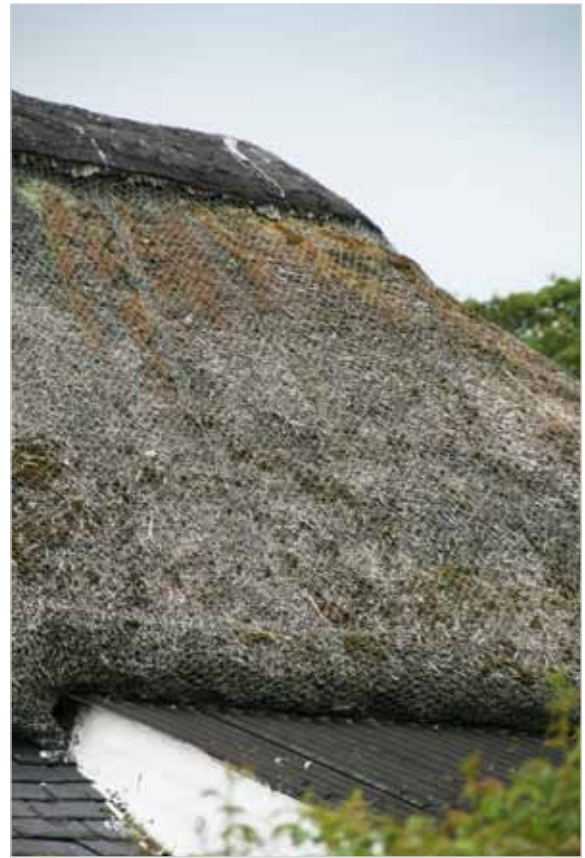
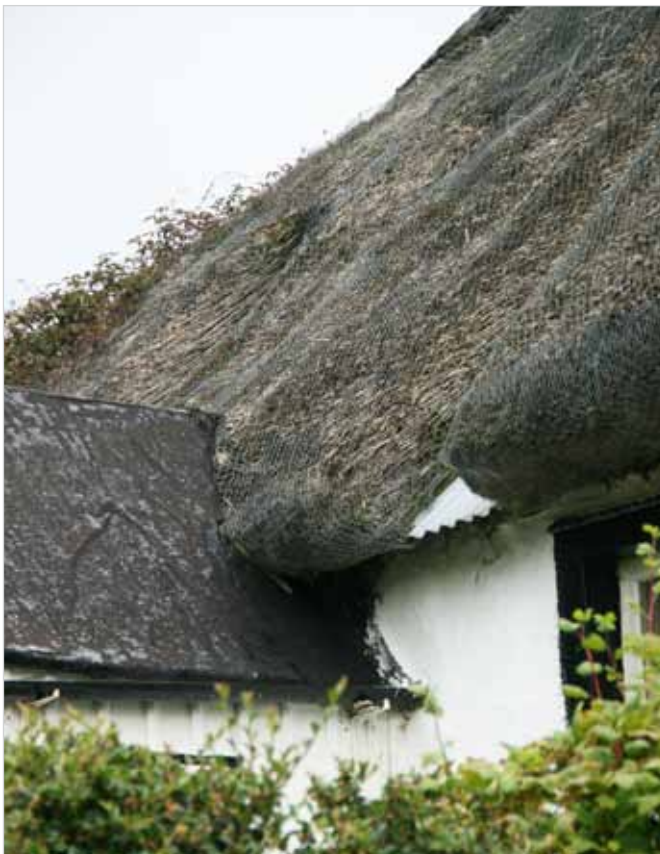
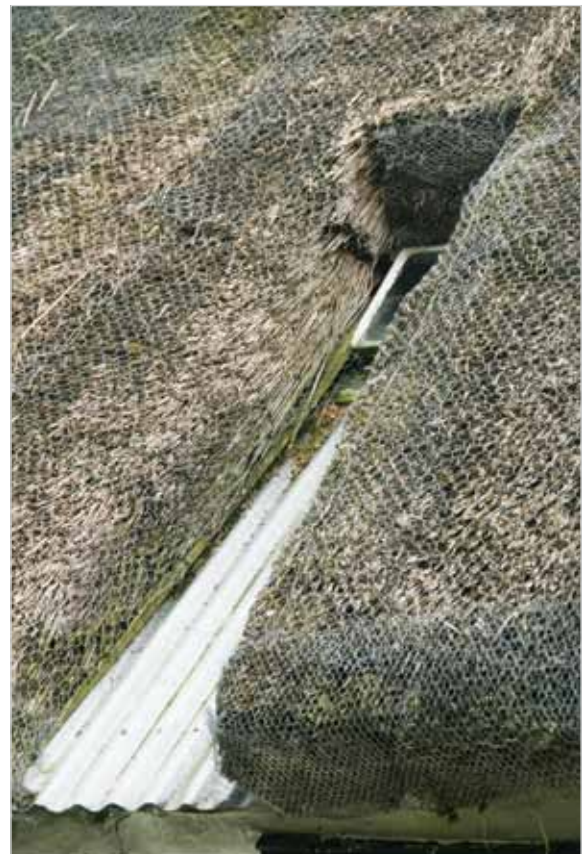
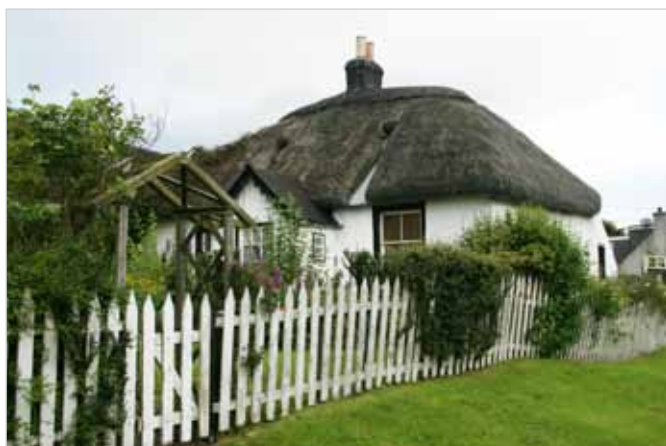
Windyhill – Highlands

Address: ..... Windyhill  
..... High Street  
..... Ardersier  
.....  
Local Council: ..... HIGHLANDS  
.....  
Grid Reference: ..... NH 78233 54965  
Date of Visit: ..... 11/07/2015  
Listing Category: ..... B  
Date Listed: ..... 17/04/1986  
Listed Building Number: ..... 1751  
Canmore ID: ..... 99002  
Building Type: ..... Cottage  
Use: ..... Residential  
Occupancy: ..... Occupied  
Buildings At Risk: ..... n/a  
Thatch Type: ..... Reed  
Ridge Type: ..... Concrete  
Condition of Thatch: ..... Fair

**Additional Notes:** ..... Circa 1800 single-storey cottage with later single-storey extension across the full length of the rear elevation. The rear extension, as well as the gabled 19th-century porch to the front elevation, does not have a thatched roof. The cottage has a single chimney stack in the centre of the concrete ridge and a steeply pitched thatched roof. On the front elevation there is a pair of small attic windows, one on either side of the entrance porch. Below the attic windows the roof is not thatched and instead has been covered with a strip of corrugated iron that extends from the bottom of the window to the eaves. The thatch has been entirely

netted, from the base of the concrete ridge to underneath the eaves. There is an amount of mossy vegetation growth across the surface of the thatch, particularly on the rear elevation. To the left of the front elevation, one of the plants from the garden has grown up onto the building and is spreading across the thatch.

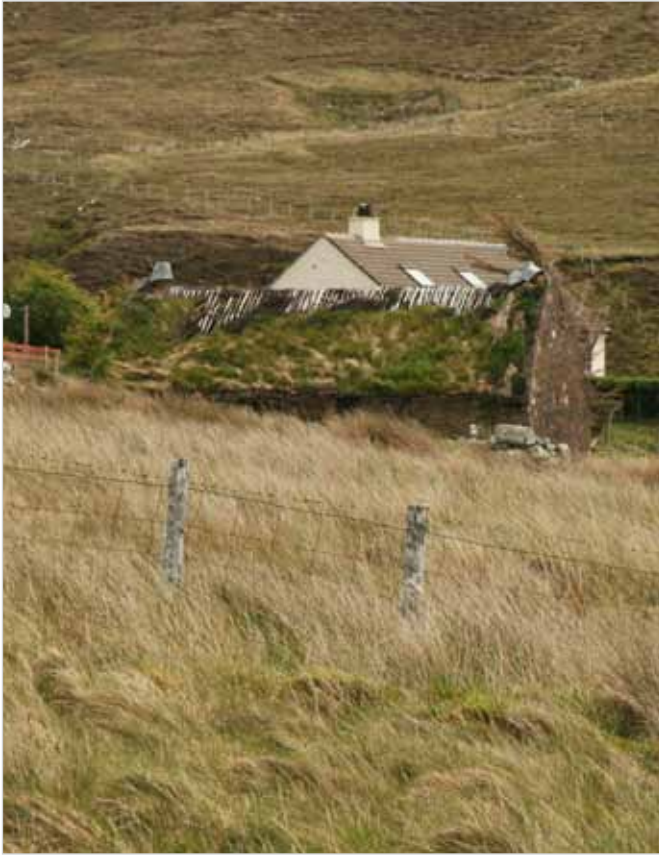
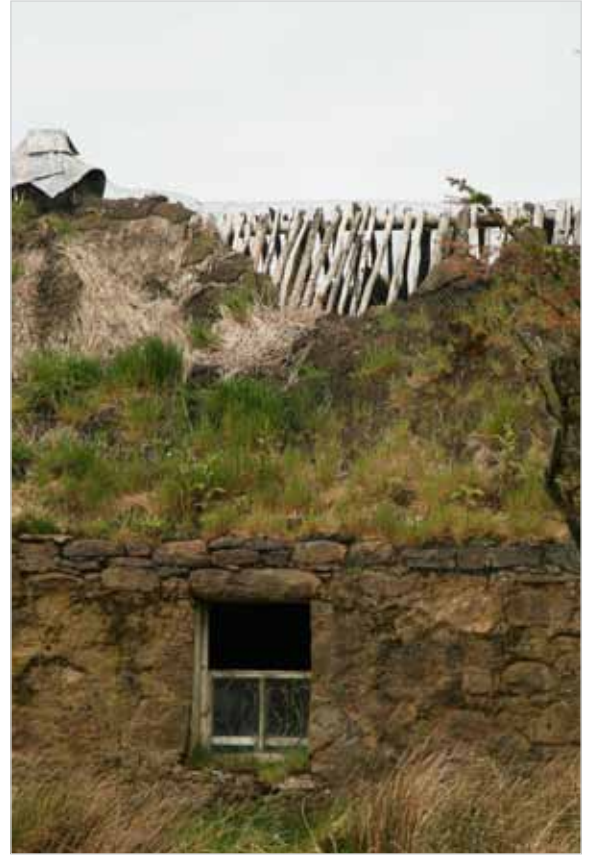
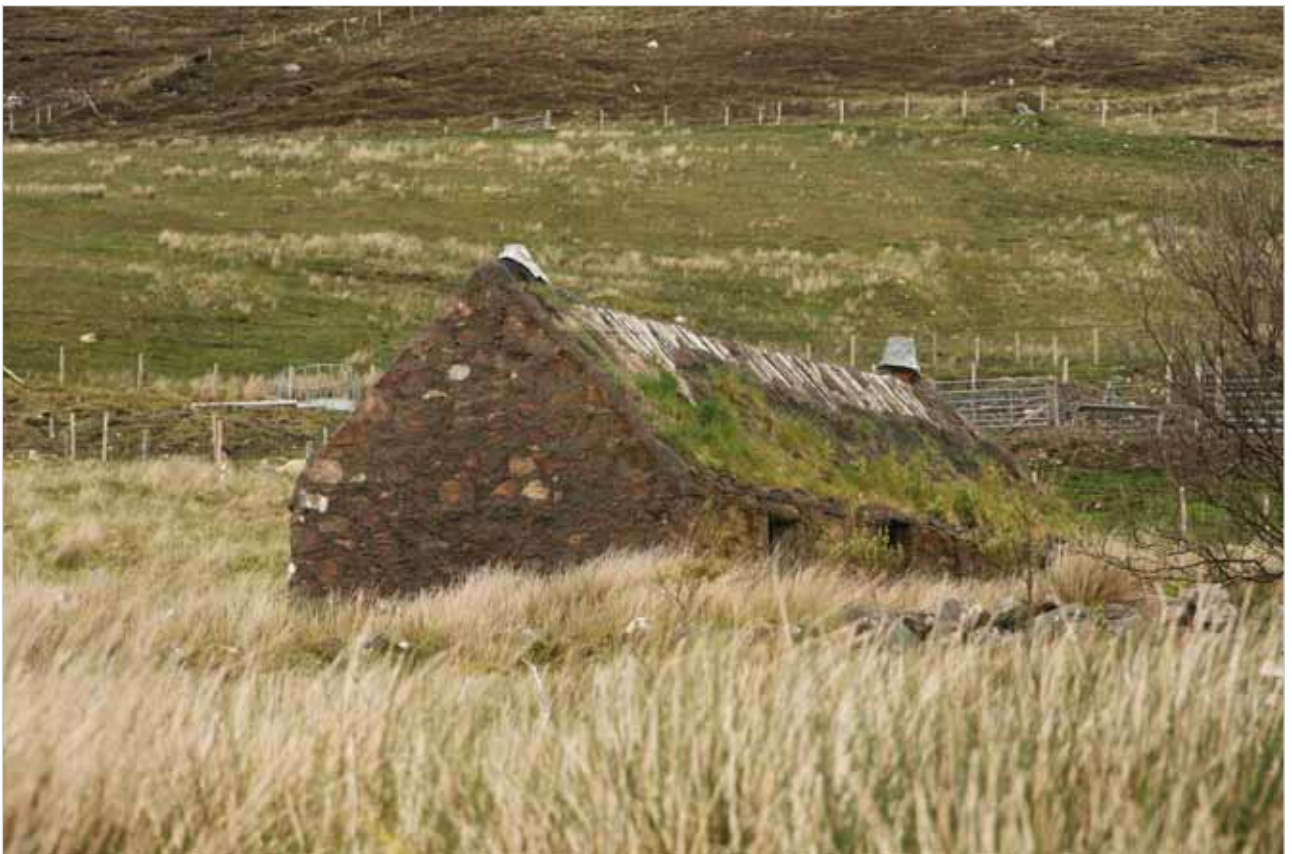
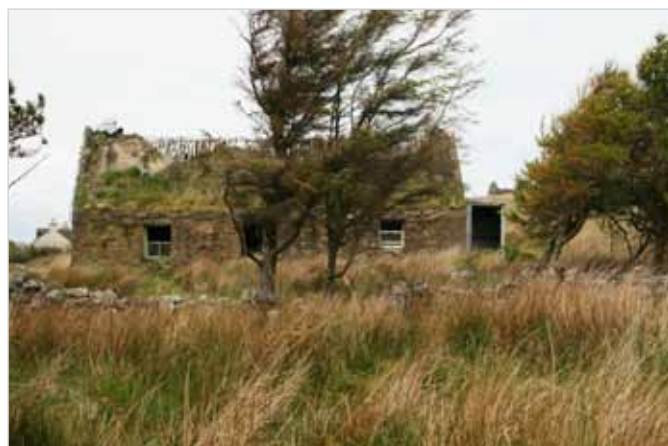
Address: ..... I I Melvaig

Condition of Thatch: ..... Poor

..... in a derelict condition. The thatched roof, along with what appears to be a layer of turf underneath the thatch, is

..... roof; however, there is no visible sign of any stone;

..... weights or ropes keeping the netting in place. ....

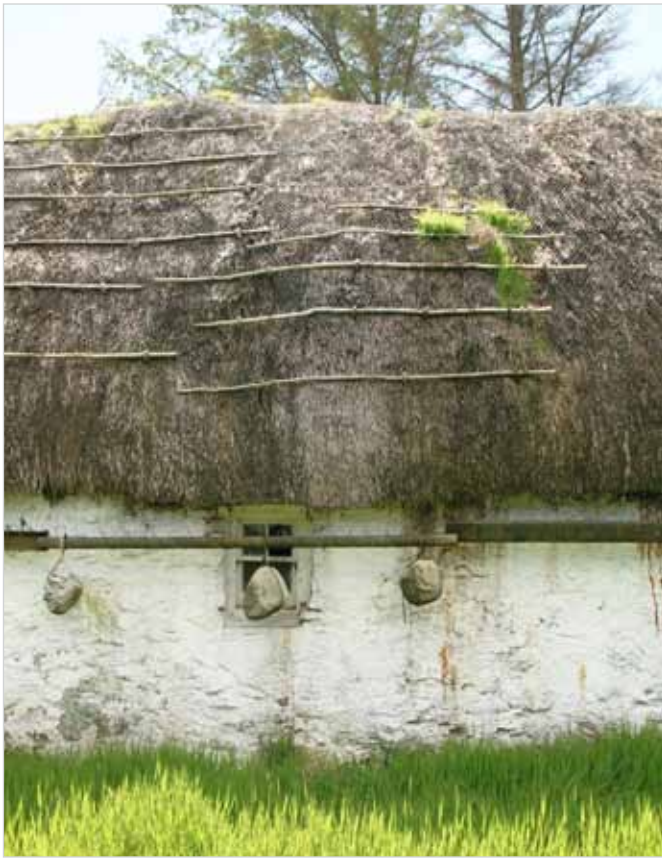
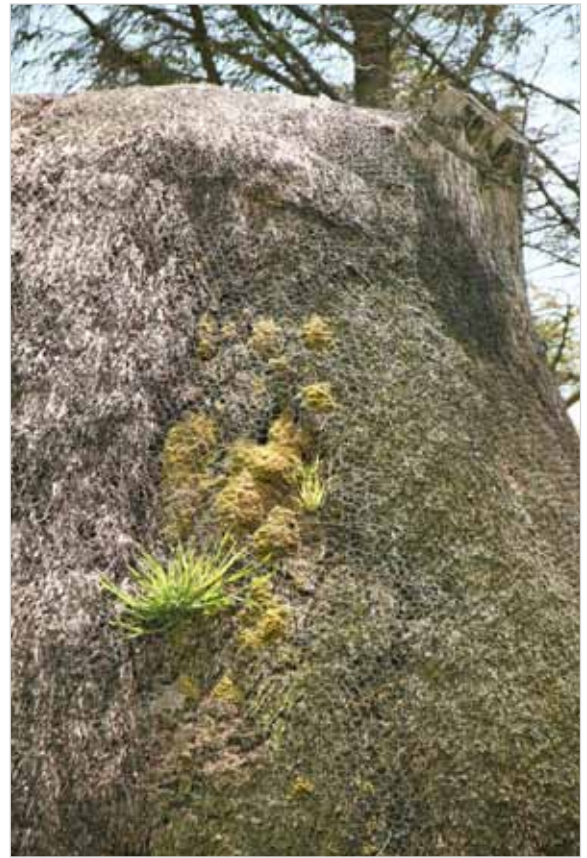
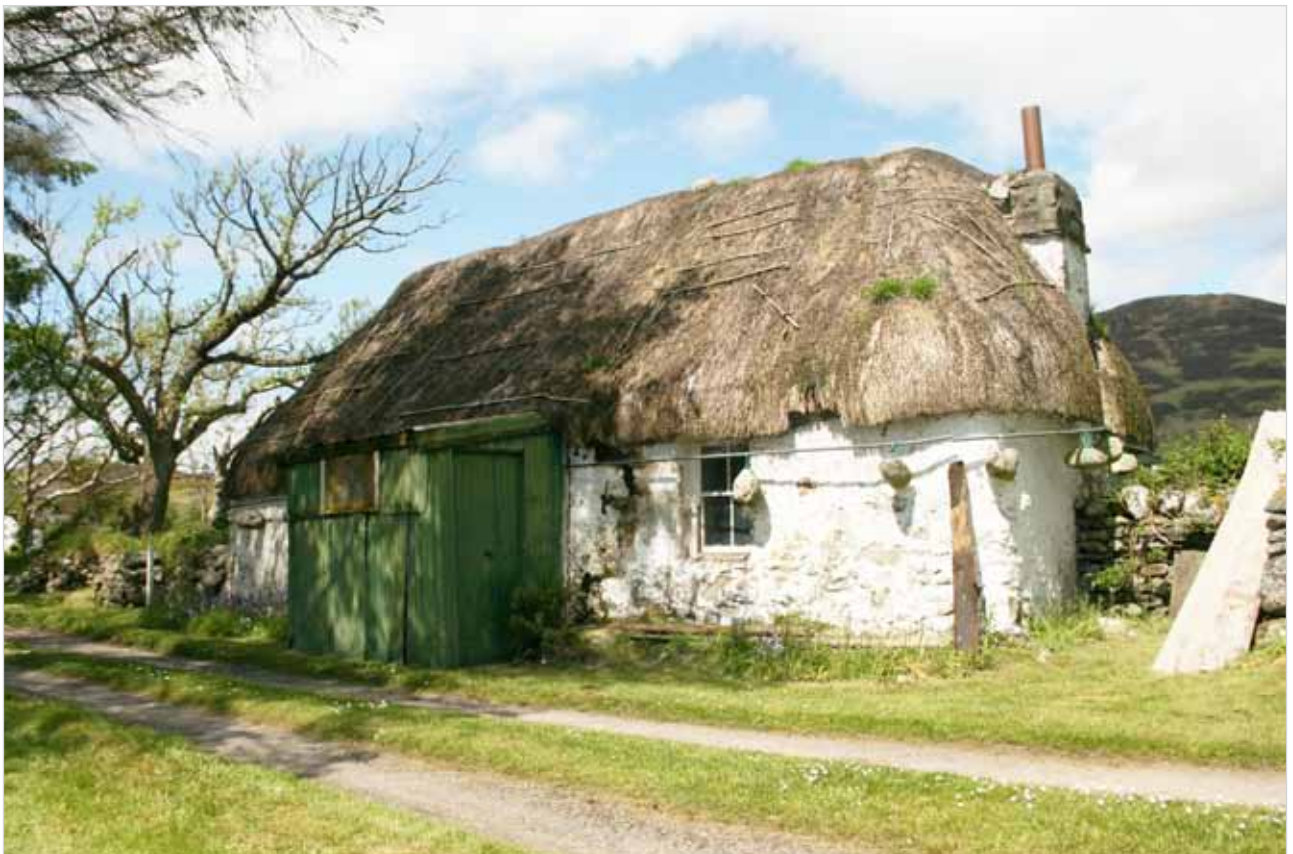
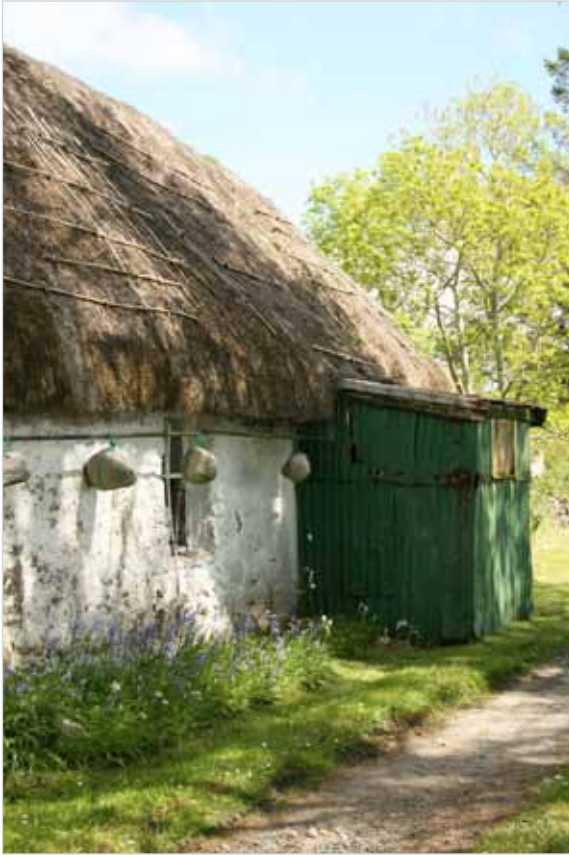
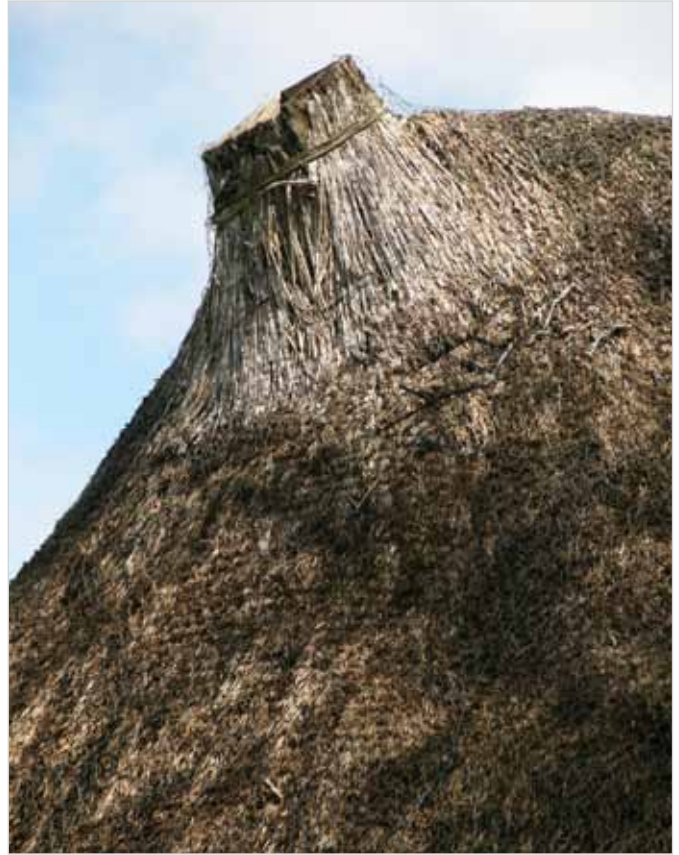
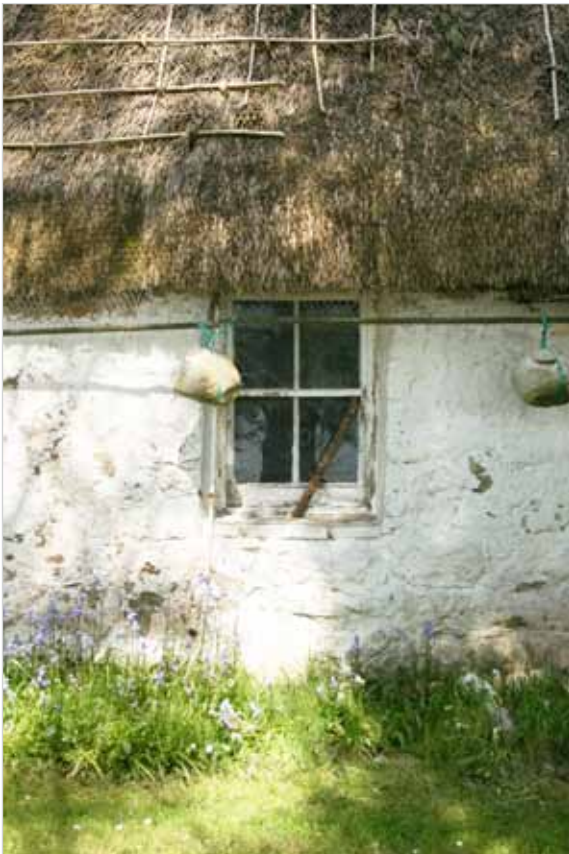
I2 Lower Ardelve – Highlands

Thatch Type: ..... Rush  
Ridge Type: ..... Thatched (Rush)  
Condition: ..... Poor

Additional Notes: ..... 19th-century cottage with later central projecting corrugated iron porch to front elevation.

The cottage is listed as having a roof of 'rush and/or straw thatch with some heather at eaves, pinned at ridge and eaves with bent hazel wands', though according to Mary Myers in her book *Western Seaboard: An Illustrated Architectural Guide* (2008), the roof 'originally of rushes and heather', was 're-thatched with rushes pinned with hazel wands in 1996'. The building has been on the Buildings at Risk (BAR) Register since 1998 (BAR reference number 876), and since then BAR has documented its deterioration as well as a series of ongoing repairs in its vacant state. The thatch has some vegetation growth throughout, patches of both moss and grass. The roof is entirely netted, and has had a number of timber branches secured horizontally across the surface of the thatch by hazel, a few of which have become loose and slipped down the roof. The netting is weighted at the eaves, by metal poles that have been hooked into the holes of the netting. The metal poles then have stones hanging from them, secured to the poles by string. Along the back elevation, two sections of the netting have been weighted by two steel beams attached to the base of the netting at the eaves, which do not have any stones hanging from them. At the west end of the ridge there is a straw-thatched wooden capping to the lum, which has been bound with twine.

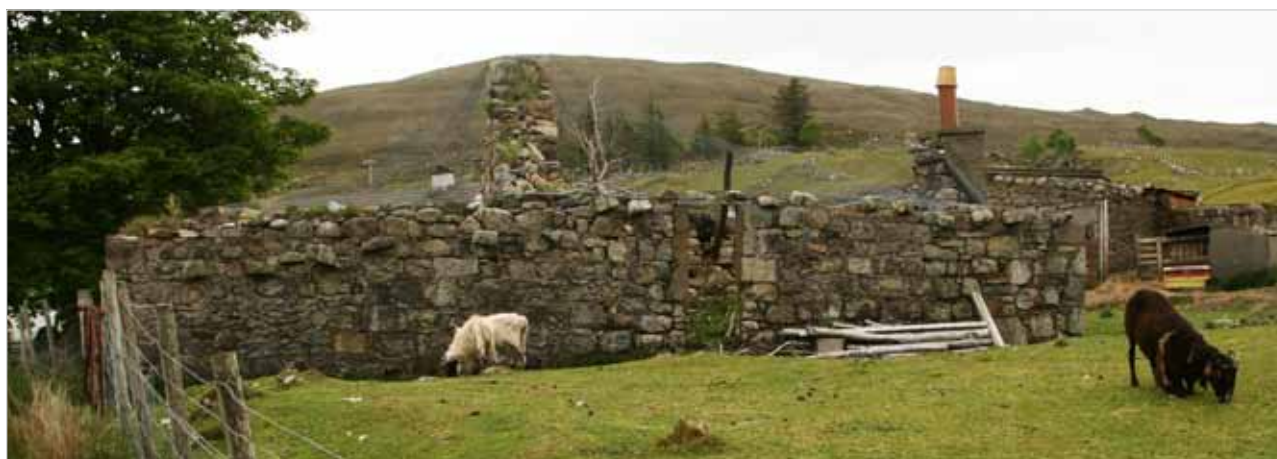
**Additional Notes:** ..... Mid/late 19th-century cottage, originally used residentially and then more recently as a museum. The building was listed in 1971 and the listing description reads that the building has '1 gable end chimney (renewed) to left' and a 'piended thatched roof'. The cottage is now a roofless ruin and has been on the Buildings at Risk (BAR) Register since 2002 (BAR reference number 2828). In 2002, *The Aberdeen Press and Journal* reported that the building had closed as a museum two years ago when a piece of timber fell from the roof and injured a visitor. Also in 2002, upon BAR inspection, the thatched roof was found to have deteriorated, with the roof trusses collapsing at one end. There are still visible signs of the netting stones and metal ties that once weighted down the thatch, as well as some material on the wallheads that could be the remains of the thatch.

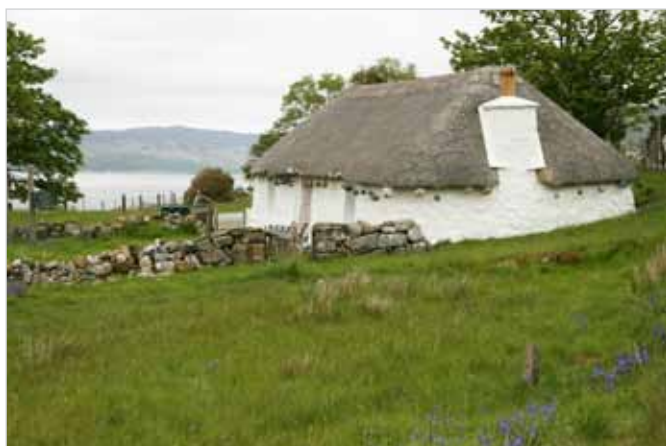
of the cottage, the stones have been secured to the netting just above the eaves, as opposed to hanging below.

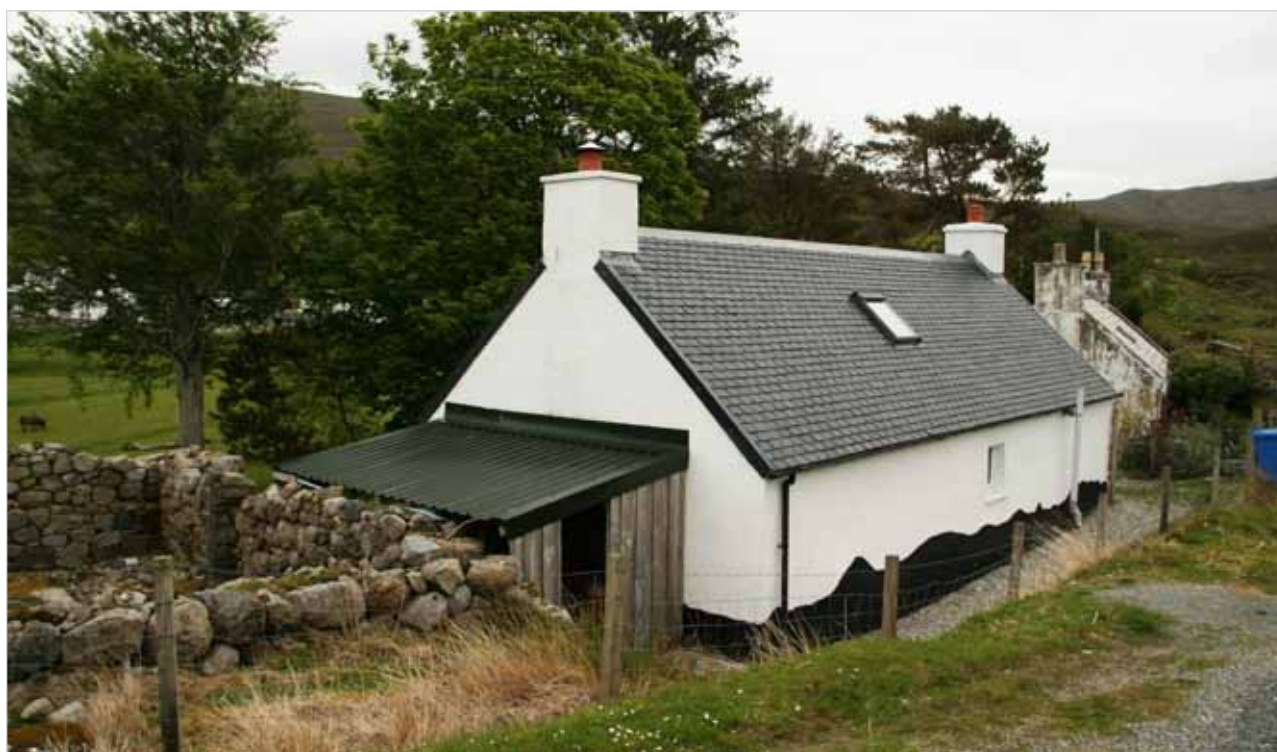
**Additional Notes:** ..... Mid 19th-century cottage, listed in 1971 as having 'gable end chimneys' and a 'piended thatched roof', however, the listed building description notes, of unknown date, read 'uninhabited; condition deteriorating'. The building has been repaired at some point and the thatched roof has been removed, replaced with slates. There is the ruin of what appears to be a small byre located a few metres to the north-west of the cottage, which exists to only a few feet in height. The listing description for this building should be updated.

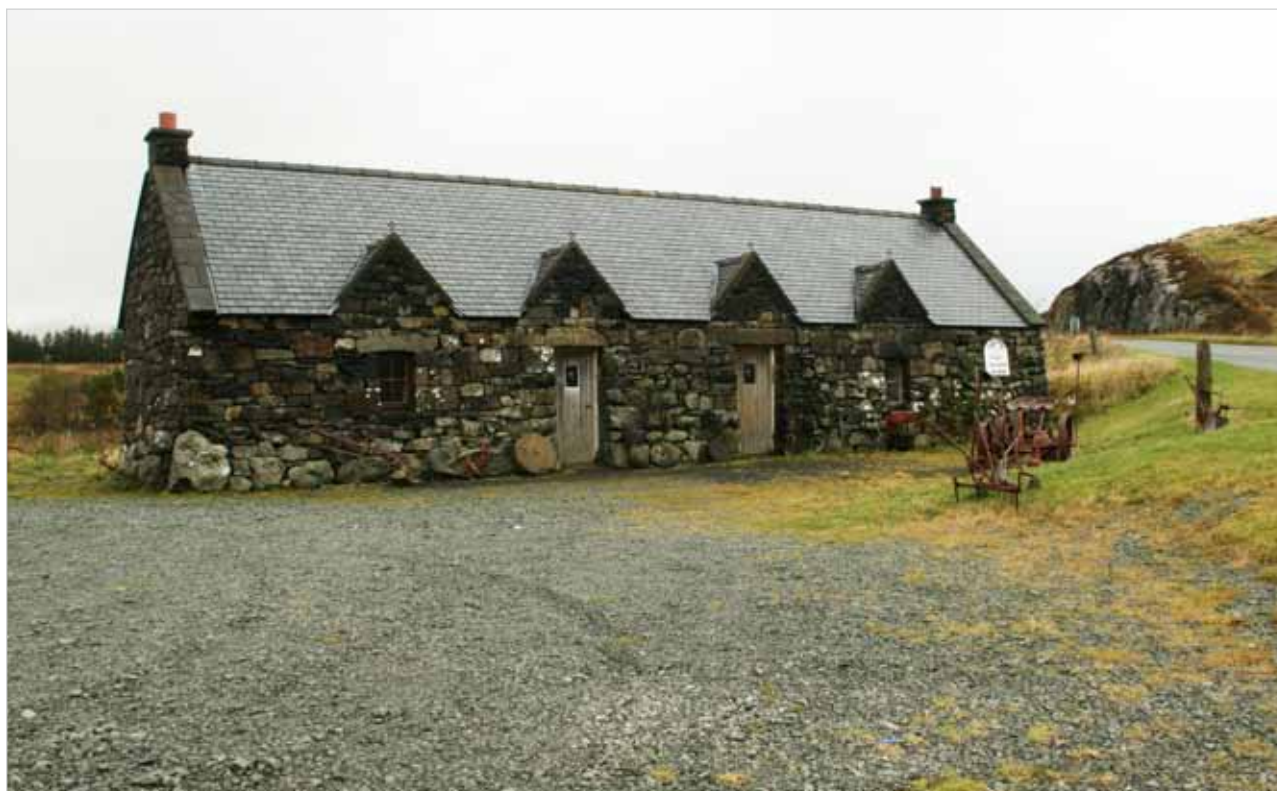
**Additional Notes:** ..... The signage on the front of the museum reads 'Taigh Tasgaidh Museum'. The listed building description reads '19th century traditional Skye house, single storey, 3 bay with centre door; rubble, rounded corners; end stacks; piended thatched roof'. The building no longer has a thatched roof; the entire roof is slated. The listed building description should be updated accordingly.
